**Evaluation of the short, medium and long term sustainability of  
Concern's WASH programme in the Kagera Region of north-  
west Tanzania**

**(December 2014)**

**Laurence Gill**

**Department of Civil, Structural and Environmental Engineering  
Trinity College Dublin**

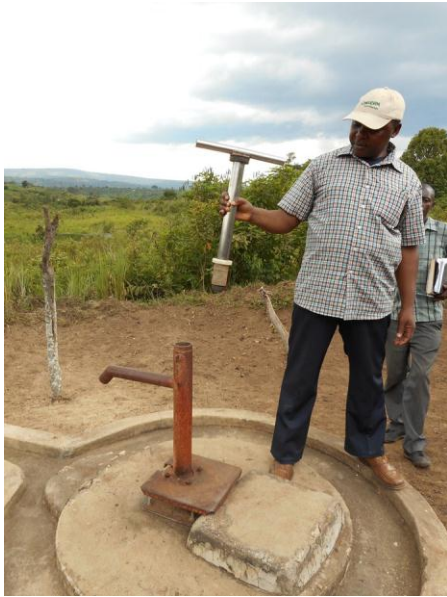
From the 17 WPs visited, only one (PE2) was not functioning due to a mechanical failure whereby the pump shaft had sheared off (see Figure 3). This had been broken since 2012, although the pump had not really been used much since 2010 as it had been totally dry throughout the dry season. The community and water committee had clearly lost the motivation to repair the hand pump, even though they had repaired it twice in the past, and

were now using a neighbouring water point (which had also installed by Concern around the same time).

**Figure 3.** Broken hand pump at PE2.

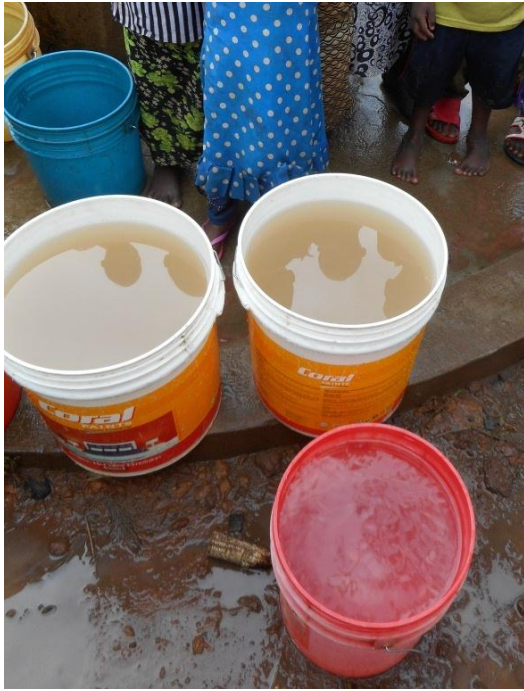
There appears to be an issue for 10 out of the 17 of the wells with the water changing colour after heavy rainfall events which indicates potential rapid pollution pathways. An example of this is shown in Figure 9 which shows the difference in water clarity from water drawn in the morning following a couple of days without rain (the red bucket) compared to water pumped during our visit just after a rainfall event (the white buckets). This is of some concern from both a water quality perspective as well as the local community's perception. As stated earlier, three of the water points were effectively failed points as they were not being used by the community who considered that the water was not good enough to use. In addition, at two of the wells, users reported that worms sometimes were in the pumped water during the rainy season. The siting of some of the wells was very close (<30 m) to surface water (rivers or other traditional wells) which provides a contamination source and potential for very rapid pollutant transport into these shallow wells (see Figure 10).

**Figure 9.** Change in turbidity of water pumped from a well following a rain event.

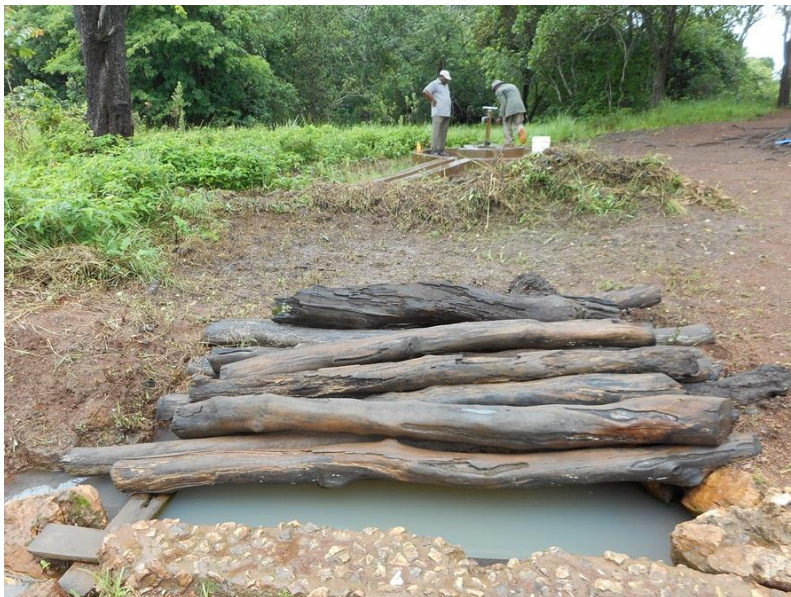
**Figure 10.** Proximity of PE17 hand pump to traditional open water source.

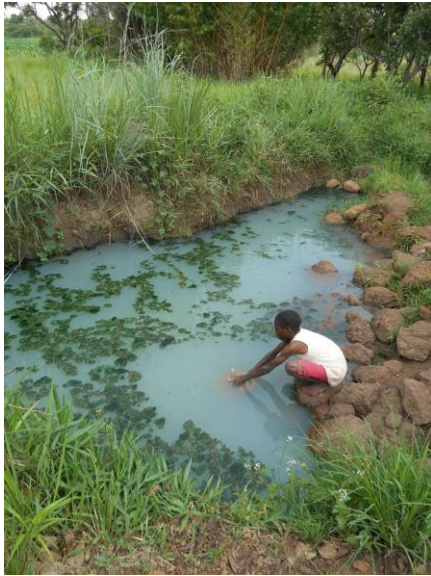
**Figure 11.** Collection of water from traditional open water source, less than 30 m away from PE14.

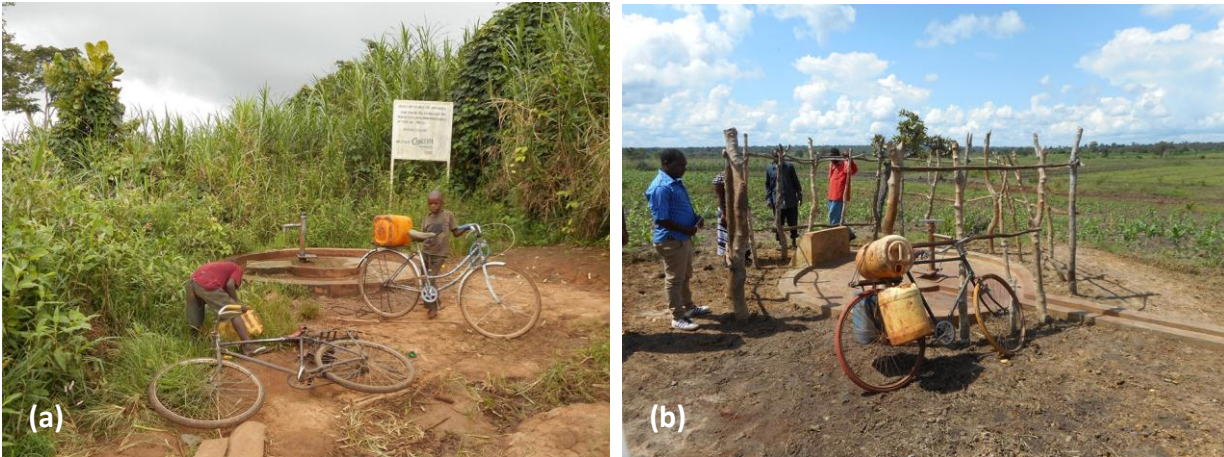
Many of the users also reported that there were significant problems with reduced yields from the wells in the dry season. Using the pumps under these conditions will put extra strain on the pump which will damage / shorten life of pump. It is not clear how the original site assessment and subsequent well design was related to the size of the population targeted at each water point or related to the water table depth. The test auger holes with determination of yield using the jolly jumper methodology were carried out in the dry season (which is good practice), but clearly the assessment was not adequate with respect to determining the sustainable yield and matching that to the expected use, particularly for some of the higher populations. An example of a well sited and installed well is PE15 (Figure 12), which had been operating for 6 years without any maintenance required (despite the fact that the committee had never received any formal training). This water point scored very highly on the infrastructure sustainability index (1<sup>st</sup> with 0.79) but low on the committee sustainability index (14<sup>th</sup> with 0.36), as shown in Table 8. Hence, this clearly indicates the importance of appropriate site selection and technology with respect to the sustainability of a water point. In contrast, an example of a poorly sited well is PE11 (Figure 12(b)) that was installed in 4<sup>th</sup> October 2013, had to be dismantled after a problem on 13<sup>th</sup> October 2013 and then ran dry in November 2013. It only started producing water again in September 2014 but the local community now complain that the water smells and so won't use it.

**Figure 12.** A tale of two water points: (a) PE15 – 6 years of operation without maintenance (b) PE11 – dry for most of its 14 months since installation and not used by community.

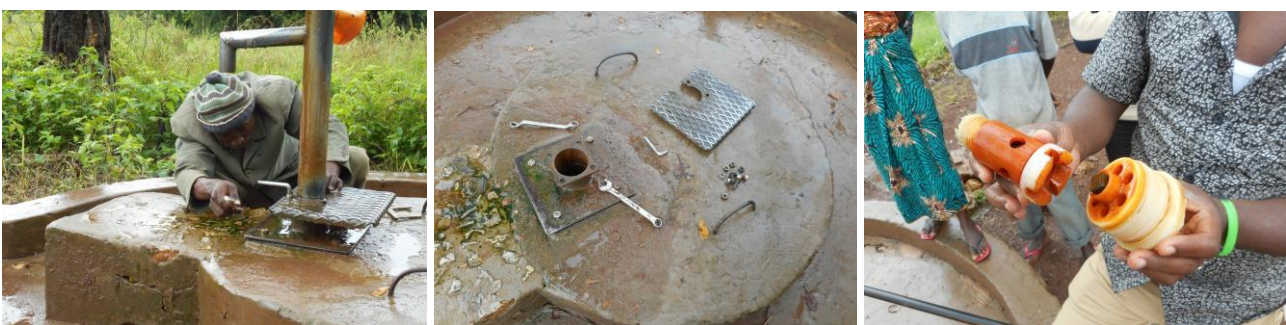
**Figure 15.** Pump caretaker for PE17 dismantling pump showing the Nira AF-85 foot valve.

None of the caretakers appeared to carry out any routine preventative maintenance and it was not clear whether this was encouraged as part of the training. The caretakers should be taught to strip the pump for routine maintenance once every 6 months in order to tighten the rods and clean the valves etc. This is a very quick procedure and can be done in about 30 minutes. Such preventative maintenance will help to maintain the caretakers' skills, engender confidence and value in the mechanic by the community, as well as preventing more catastrophic failures. One of these routine maintenances for example, could also be scheduled for the refresher training after 12 or 18 months post-installation from which feedback can be given by the NGO to the mechanic and also lessons learnt by the NGO.
