42nd WEDC International Conference

Promoting CLTS in Conflict Zones – South Sudan

W. Karinga, F. Flachenberg
South Sudan

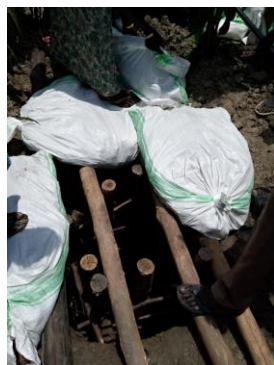
Figure 1: A completed pit under lining in Kurkal

Concern's WASH team promoted the lining of latrines with local sticks. Household members were encouraged to collect the sticks from the bush and do their own lining of the pits, following a training from Concern in how to do so. Adhering to the 'community-led' aspect of CLTS, households were free to choose whether or not to collect sticks and construct the lining of their latrines. Despite Concern's recommendations, some households chose to construct latrines without lining the pits.

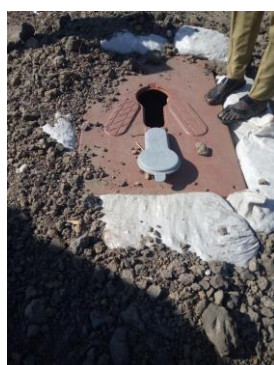
Figure 3: A lined pit with slab.

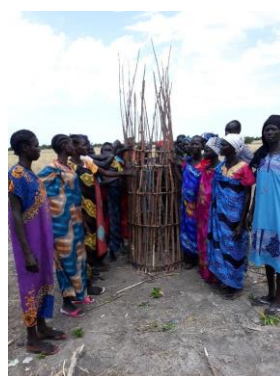
Figure 4: Pre-woven structure for lining.

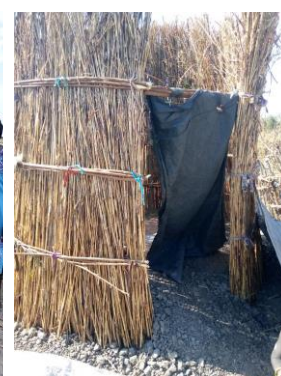
Figure 5: A completed latrine constructed by community members with local materials.
